# **Behavioral performance during vibration and shock for a tactical grade IMU**

**R. Holm, H. Schou, H. R. Petersen, M. Horntvedt**

Sensor AS,  
Knudsrodveien 7  
P.O.Box 1004  
3194 Horten  
NORWAY

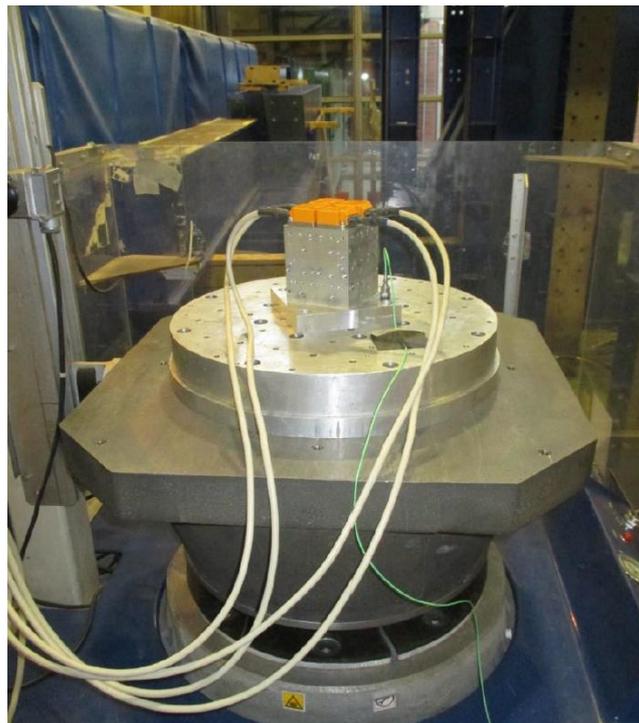
Tests #3 and #4 were performed using a conventional shock tester, as shown in figure 17:

Figure 17: Test set-up for shock tests #3 and #4 (testing in z-direction)
